Field Testing and Load Rating Report for Bridge No. 4, Hybrid Composite Beam Span, at Fort Knox, Kentucky

Contractor's Supplemental Report for Project F12-AR15

**FIELD TESTING AND LOAD RATING REPORT:
BRIDGE NO. 4 - HCB SPAN – FORT KNOX, KY**

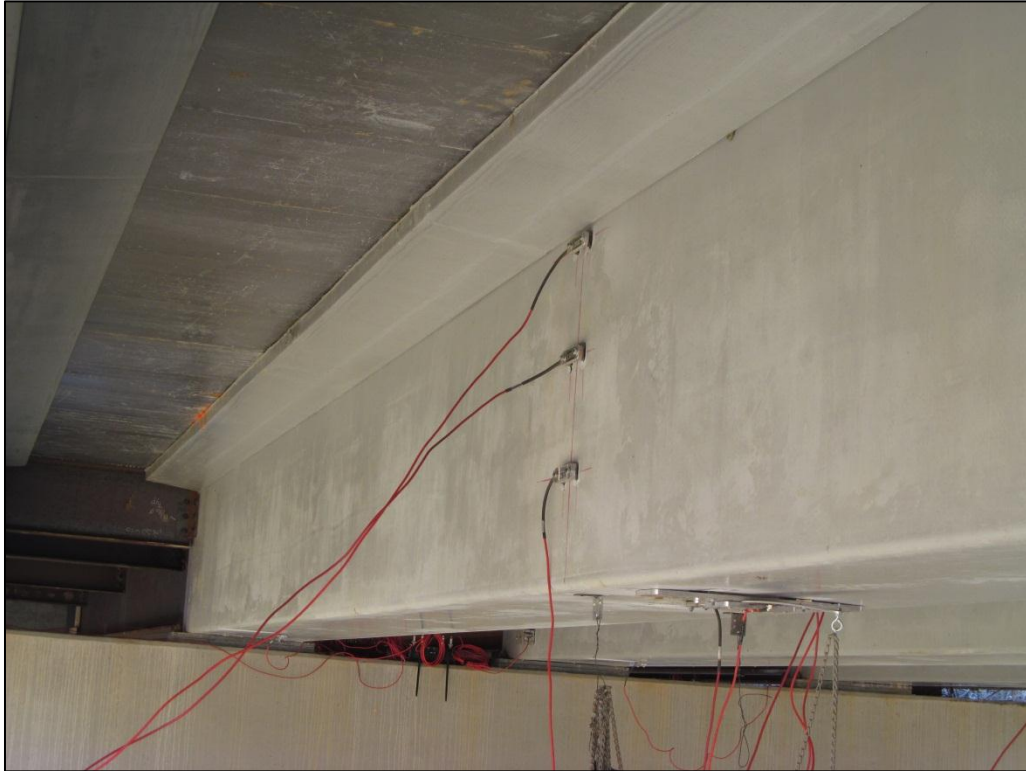
Figure 1.1 – Midspan instrumentation with strain, displacement and rotation sensors (typical of both test phases).
